Investigation of an Unusual Reformer

Tube Failure

Trinidad and Tobago Methanol Company

IMTOF 97

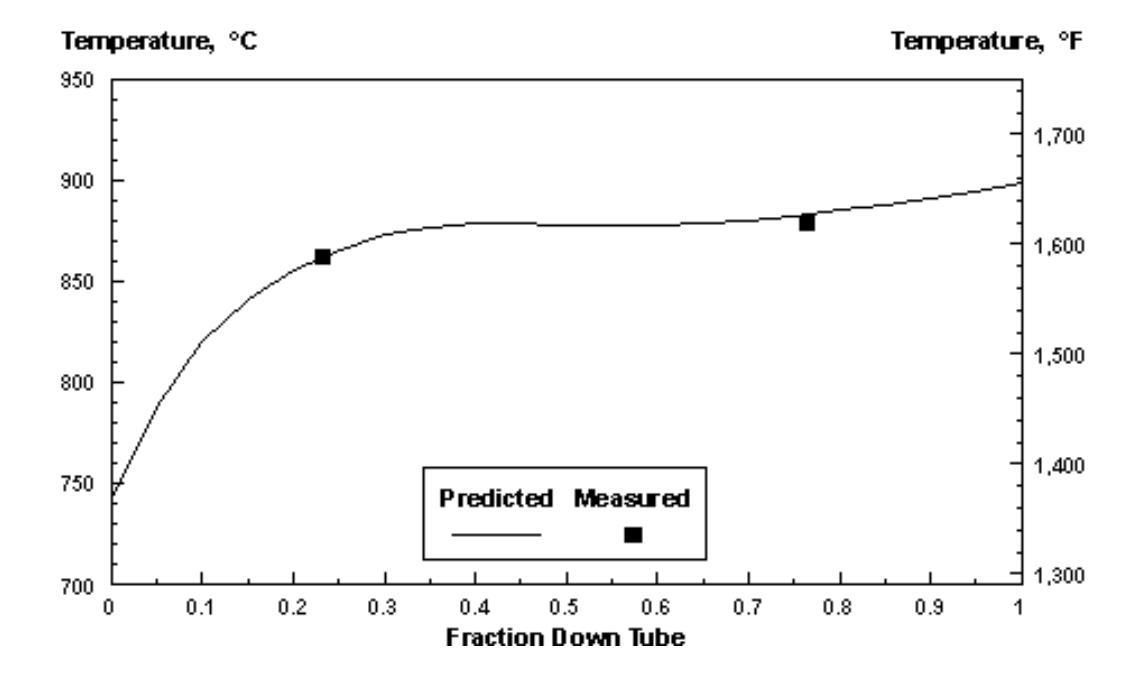
Figure 1 : Reformer Tube Temperatures

As indicated the unusual feature of the failures was the fact that they occurred at the bottom of the tubes, between the fluegas extraction tunnels. Tube failures in this region of top-fired reformers are becoming more common, and this is discussed in more detail in Reference 2. Briefly, this can be attributed to the adoption of shaped (4-Hole, for example) reforming catalysts. These catalysts reduce the tube wall temperatures along the whole length of the tube due to the increased activity and heat transfer performance. However, the point of maximum temperature is moved from the top section of the tube with ring catalysts to the bottom section of the tube with the shaped catalysts. Furthermore, it is difficult to accurately measure the tube wall temperatures in this region of the furnace and the actual tube temperatures may be higher than expected.

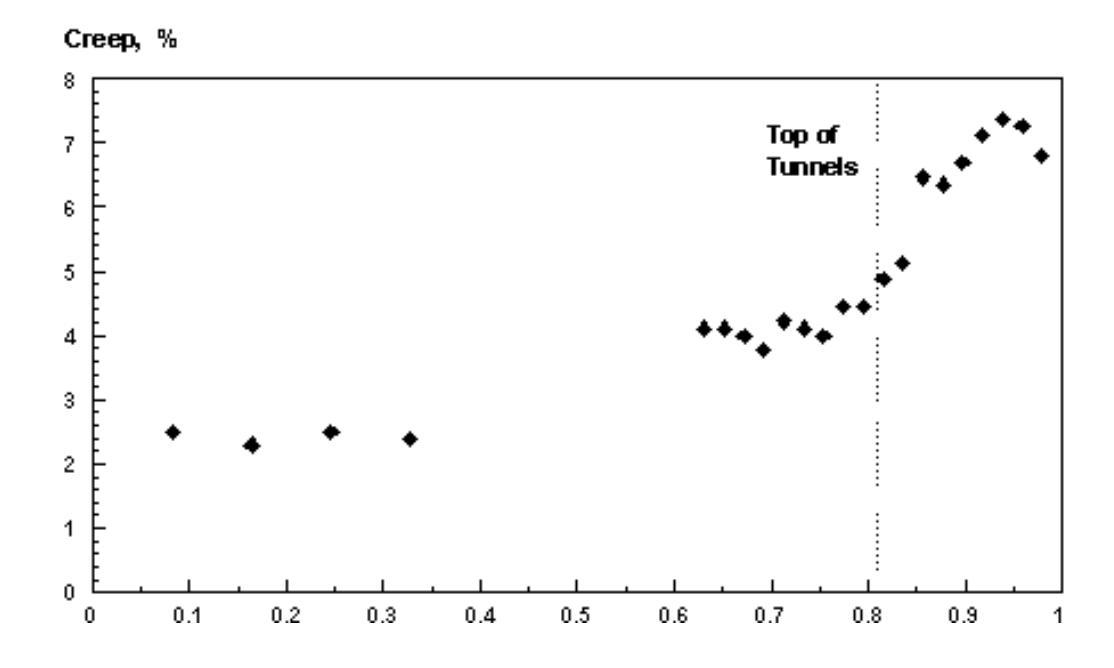
Figure 2 confirms that the damage to the tubes was confined to the bottom 2.4m (8ft) of the tube. An initial observation suggested that the damage was related to the presence of the fluegas extraction tunnels, with the position of the tunnels being shown in Figure 2. Therefore, the second stage of the survey involved the measurement of the tube diameter of the bottom section of all of the tubes within the furnace taken at 0.6m (2ft), 1.2m (4ft), and 1.8m (6ft) from the floor of the furnace. The results of this survey are presented as a distribution curve in Figure 3. From these data it can be seen that significant numbers of tubes had sustained extreme levels of damage, measured as creep levels in excess of 6%. The data also show that at least 50% of the tubes had exceeded 4% creep, which indicated the need for a retube within a short period of time.

One of the first anomalies with the tube damage and failures in this furnace becomes apparent when Figures 1 and 2 are compared. In normal operation creep is predominantly dependent upon the tube operating temperature and the creep damage should follow the same profile as the tube temperature. Therefore, continuous operation at the temperature profile given in Figure 1 should not result in a creep damage profile as found in Figure 2.

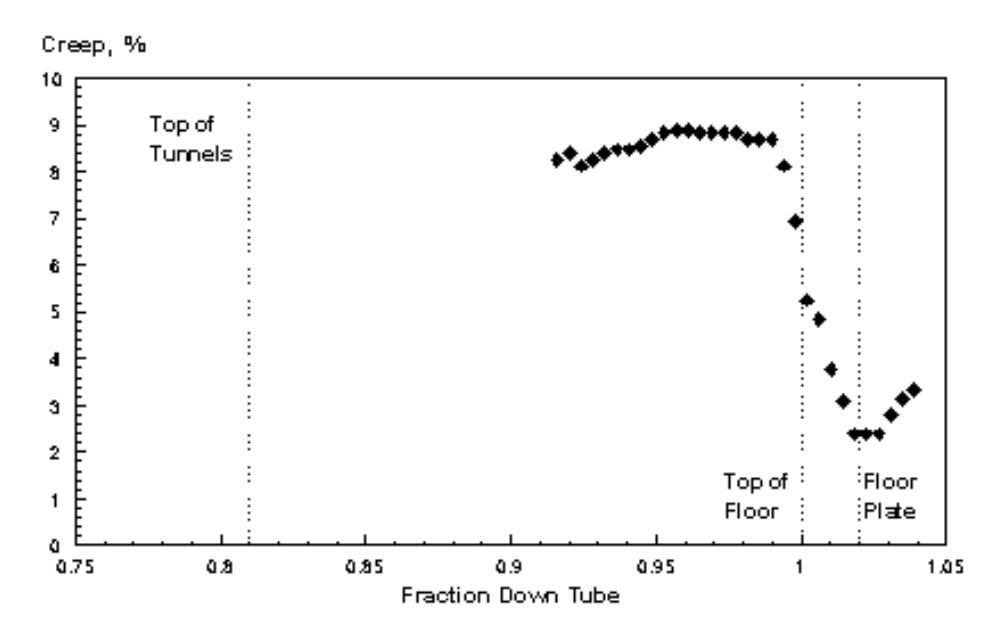
Figure 4 : Creep Measured in Sampled Tube

This tube exhibits the same high levels of creep within the tunnel region of the furnace as the data presented in Figure 3. One of the most important features of this graph is the presence of creep in the portion of the tube which is outside of the radiant section of the furnace. This part of the tube operates at the process gas exit temperature, a temperature (840-860°C) which is much lower than the tube design temperature and should therefore never be subject to creep damage during normal operation. Furthermore, the tube temperature will be almost constant from the upper surface of the floor through to the exit headers since the tube temperature is controlled by the process gas exit temperature. Based on a constant tube temperature, the creep exhibited by the tube from the top of the floor downwards should be roughly constant.

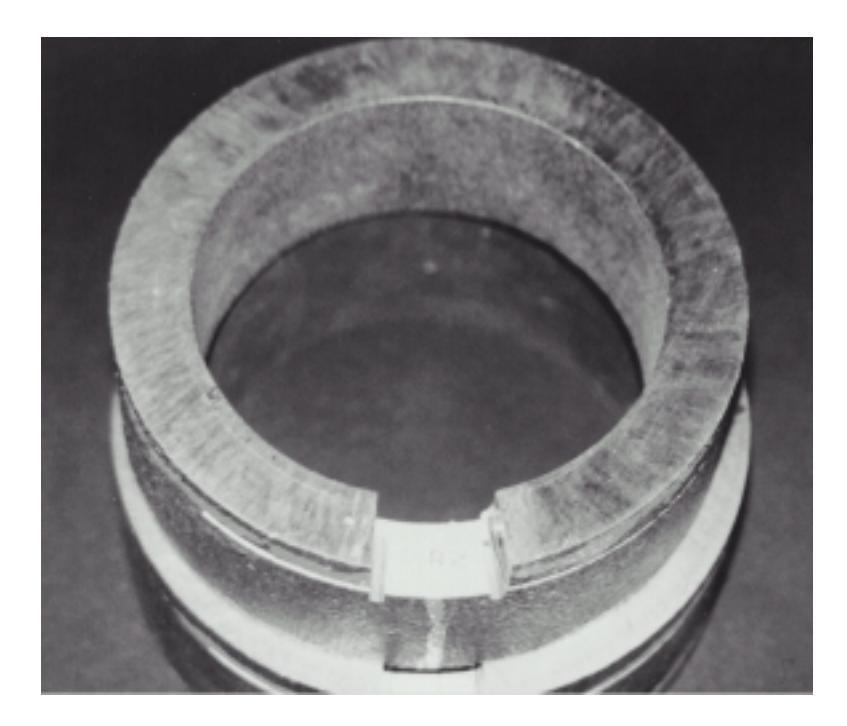
Figure 5 Damaged Tube Compared to Normal Tube

This photograph illustrates the substantial increase in tube diameters at the bottom section of this furnace. Microscopic investigation of the damaged tube revealed an unusual pattern of damage. Figure 6 shows a micrograph of the damage found in the tube. Figure 7 is a micrograph of classical creep fissure damage in a reformer tube for comparative purposes.

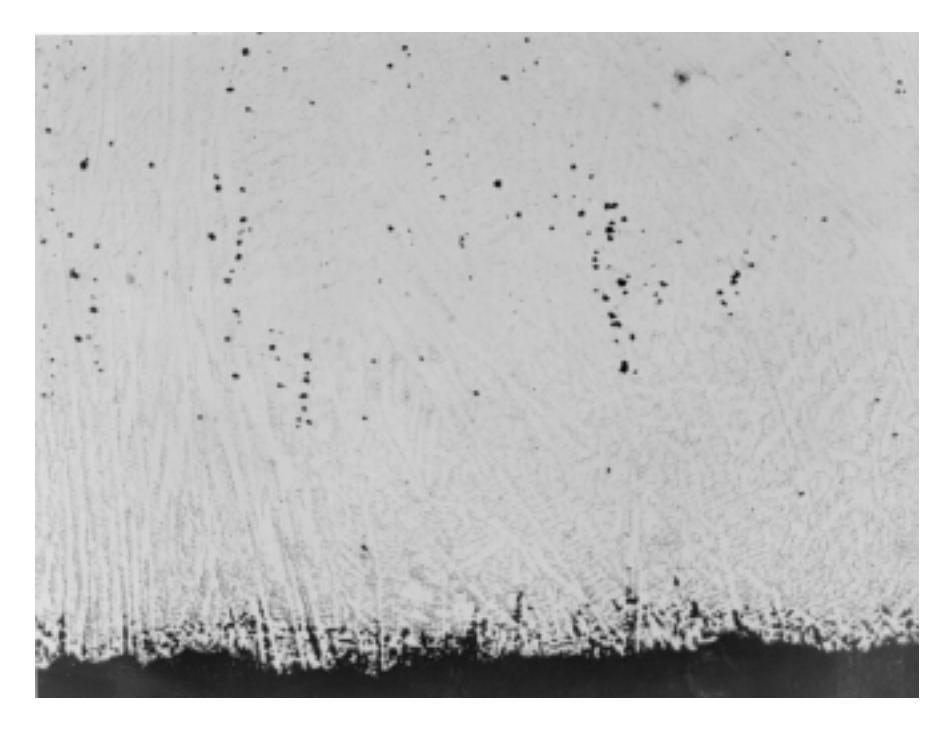
Fig 6 Micrograph of Damaged Tube

Figure 6 shows the damage in the sample tube to be present as a series of isolated voids throughout the depth of the tube wall. Typically in creep that is governed by maximum temperature gradient (i.e. in the upper section of the tube length) these stresses are maximised at the inner surface and creep voids reflect this with a pattern that is predominant between the inner wall and outer radius position (see Figure 7). The extent of voids through the wall of the tube suggests that steady state, fully relaxed stresses are playing a significant role in life consumption. Therefore tube life in this reformer may be controlled not by the position along the tube at which through-wall temperature gradient is at a maximum but that a which the mid-wall temperature is maximum.

Several micrographs showed a ring type effect, which suggests that the damage occurred as a series of short term stress events. Under normal operation at elevated temperature which results in tube creep, the voids migrate and elongate to form creep fissures. In Figure 6 fissures have not formed, therefore it can be concluded that the stress and temperature which the tube has been subjected to in normal operation are too low for creep at a significantly high rate to occur. This is supported by the fact that in the upper half of the furnace the average creep level was 1.1% with a high of 2.5%, except for 5 tubes. A further factor with the tube damage is that the voids are not aligned in any particular direction. Normal creep damage is unidirectional since the hoop stress is the dominant stress in the tube. Therefore, normal creep results in creep fissures in a single direction.

It was stated that the damage seems to have occurred as isolated events. The presence of voids within the metal without any indication of gross creep damage suggests that the tube may have been stressed in excess of the yield stress of the tube for a short period of time.

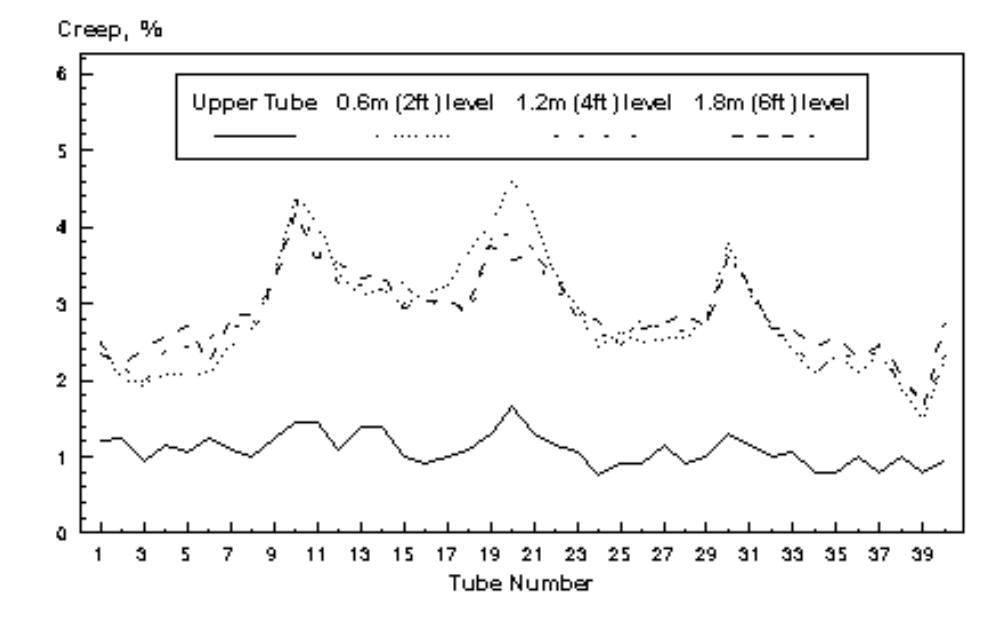
Figure 8 : Mean Creep Distribution by Tube Number

Mean creep (by tube number) was first compared as presented in Figure 8. It shows that differences along the rows are dominated by the position of the tube. This points to the higher radiative heat input experienced by the end-tubes and tubes at the quartile locations (10-11, 20-21 and 30-31) where tube spacing is approximately twice the

spacing between other tubes. That the effect is evidenced in the upper region supports a purely radiation impact rather than one associated with a pattern in the flow of flue gas down the reformer and into the tunnels. One is therefore drawn to the belief that a radiative effect, different from and not necessarily driven by the effect in the upper region, is one dominant factor at the bottom of the tubes. Figure 8 also dramatically demonstrates the point made earlier on the difference between the creep experience at the top and bottom of the tubes.

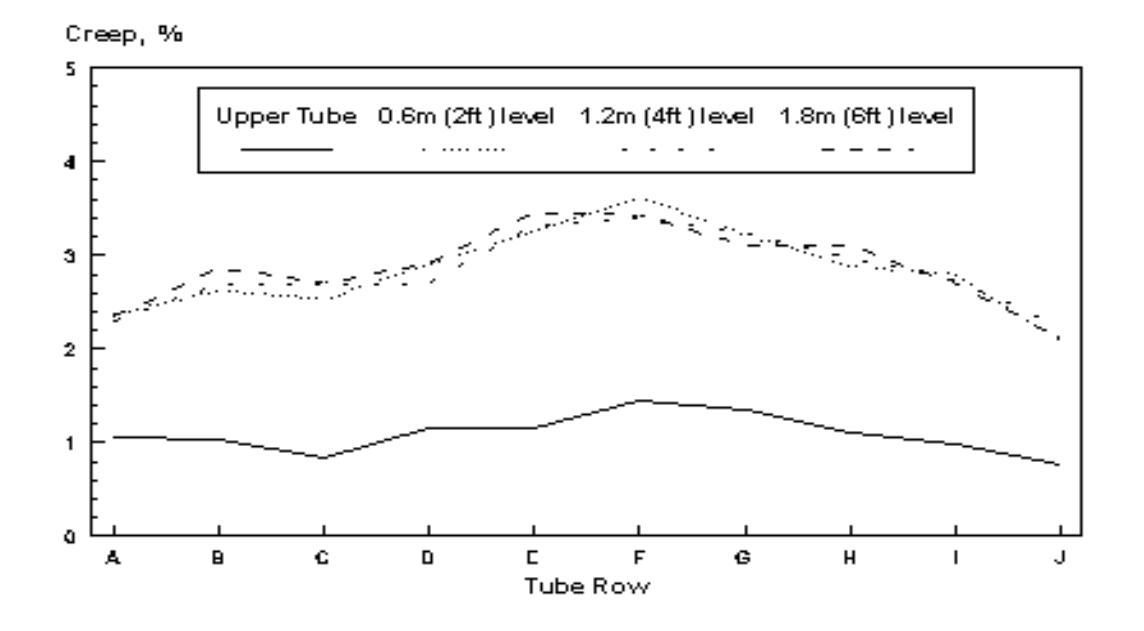
Figure 9 : Mean Creep Distribution by Tube Row

The creep data as presented in Figure 8 did not permit any inference on differences at the different levels at the bottom. Significance testing (using 'T' and Mann-Whitney Tests) established that the 0.6m and 1.2m (2 ft and 4 ft) data sets were similar populations (with a 95% probability). However, the 1.8m (6 ft) data set was significantly different from the lower two sets. An explanation for this result is found in considering that the tube region between the tunnels is impacted by radiation from the upper regions of the reformer. This impact however is reduced as the tubes move deeper within the tunnels and are shielded by the tunnels themselves. The evidence of similarly in the two populations of data for the 0.6m and 1.2m (2 ft and 4 ft) levels suggest a uniformity of effect that is not consistent with a driving force that varies along the tube length (i.e. temperature). It therefore supported the belief that effect is not associated with normal operations. Consideration of the data by row rather than tube number yields no inconsistency with the foregoing analysis (Figure 9).

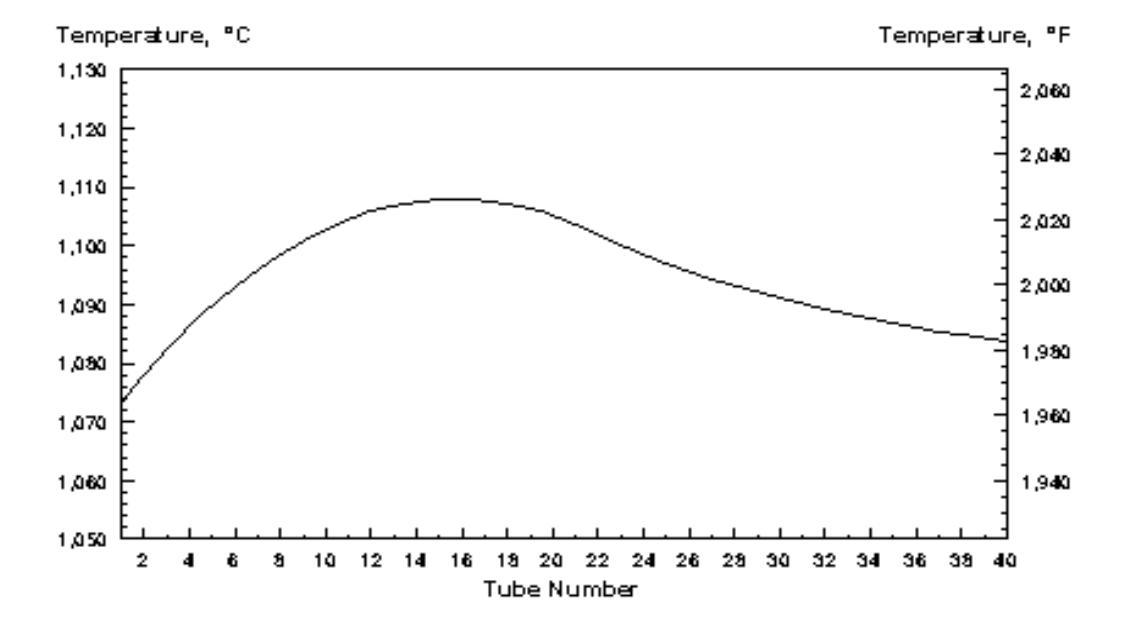
Figure 10: Fluegas Temperatures With Tunnel Burners

Increasing the heat release by a factor of ten is estimated to result in flue gas temperatures just in excess of 1100 °C and a tube temperature increase of 45 °C. This level of increase could be significant and would result in a flue gas profile as shown in

Figure 10. This profile tends to provide evidence to implicate the tunnel burners. This, however, is weakened by the reality of high creep levels in the tube positions 1 - 5 and further in that the pattern of Figure 8 (i.e. elevated at the centre) is reflected in Figure 9, which considers the creep data by Rows.

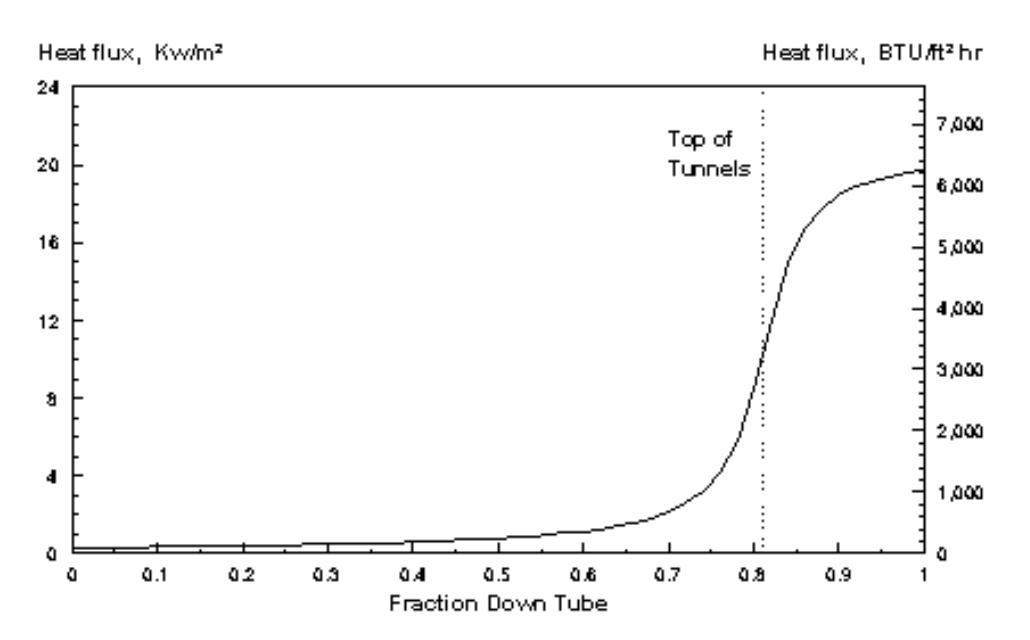
Figure 11 : Heat Flux After Reformer Trip

Figure 11 is a plot of the radiant heat flux received by the furnace tubes along the tube length in the period after a reformer trip. This plot confirms that the tunnels do in fact dominate the heat transfer within this period of reformer operation. If Figure 11 is compared with Figure 2, the creep profile, both graphs can be seen to have a similar profile. This finding infers that there is a potential correlation between the two.

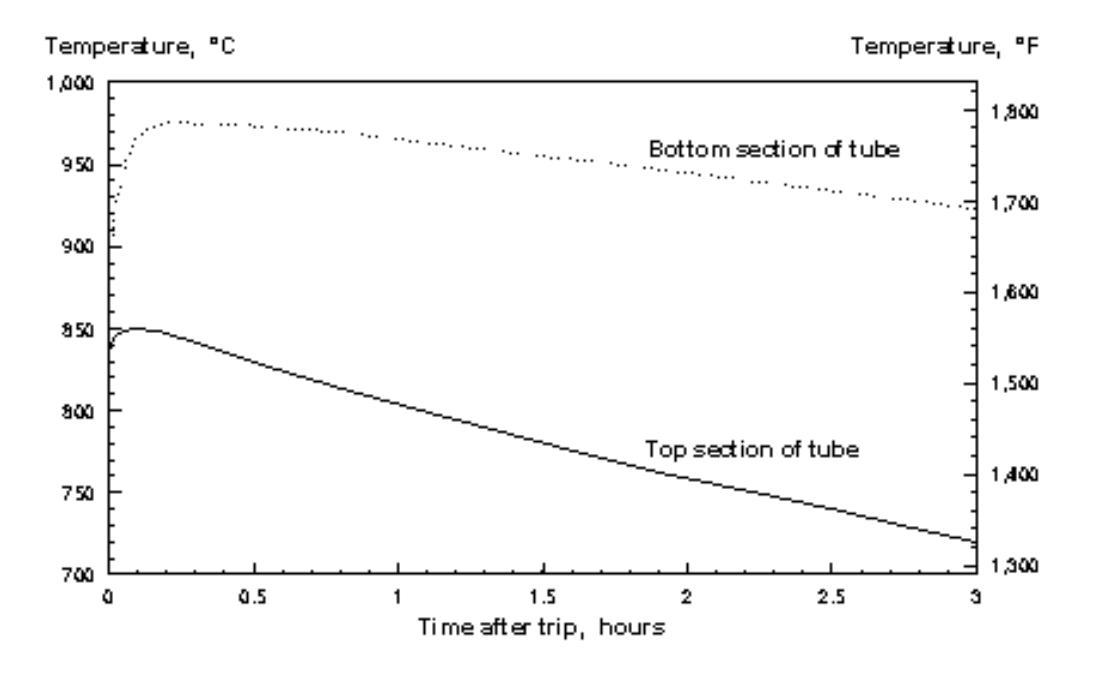
Figure 13: Tube Temperatures After Reformer Trip

The tube temperatures quoted in Figure 13 are the average temperatures of the length of tube between the tunnels (bottom) and the length of tube in the furnace above the tunnels (top). From this graph it can be seen that the tube temperature in the top of the furnace falls rapidly due to the low thermal capacity of the ceramic fibre blanket. However, the temperature of the tube within the tunnel region heats up to 975°C (1790°F) and remains hot for many hours after the trip whilst the upper tube cools.

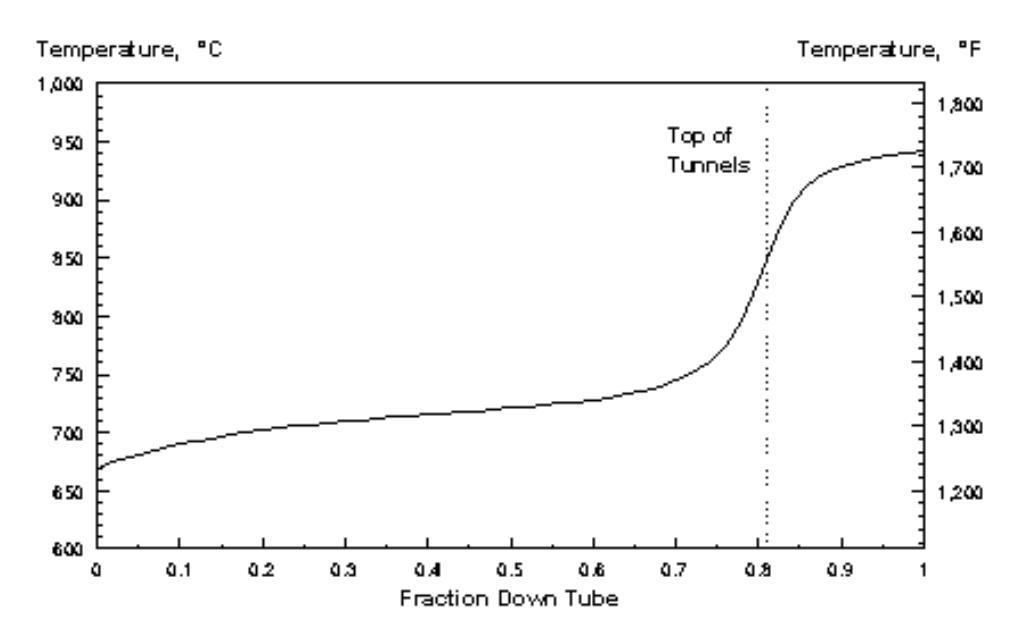
Figure 14 : Tube Temperatures 3 hours After Reformer Trip

At any given time after the trip, an approximate temperature profile down the length of the tubes can be determine by a combination of the temperatures in Figure 13 and the heat flux profile in Figure 11. An approximate tube temperature profile 3 hours after the trip is given in Figure 14, based on the average tube temperatures of 922°C (1692°F) at the bottom and 719°C (1326°F) at the top. From Figure 13 the observation that the tube temperatures are cold at the top and hot at the bottom, after a full reformer trip and box in, is confirmed.

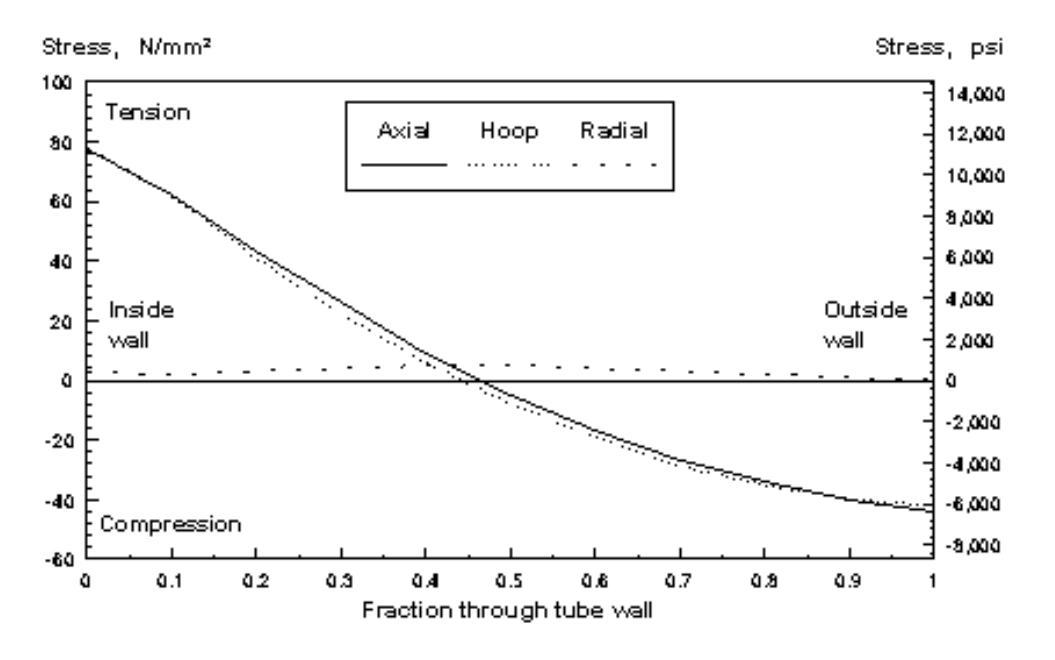
Figure 15 : Tube Stress During Reformer Restart

This shows the stress levels through the tube wall in the 3 orthogonal directions. The peak tensile stress is found on the inner surface of the tube, with the model assuming that all of the tube wall thickness is sound metal. An important feature of this graph is that the peak stress occurs in both the hoop and the axial directions, rather than in a single direction. This provides the mechanism required for volumetric creep rather than the normal unidirectional creep.

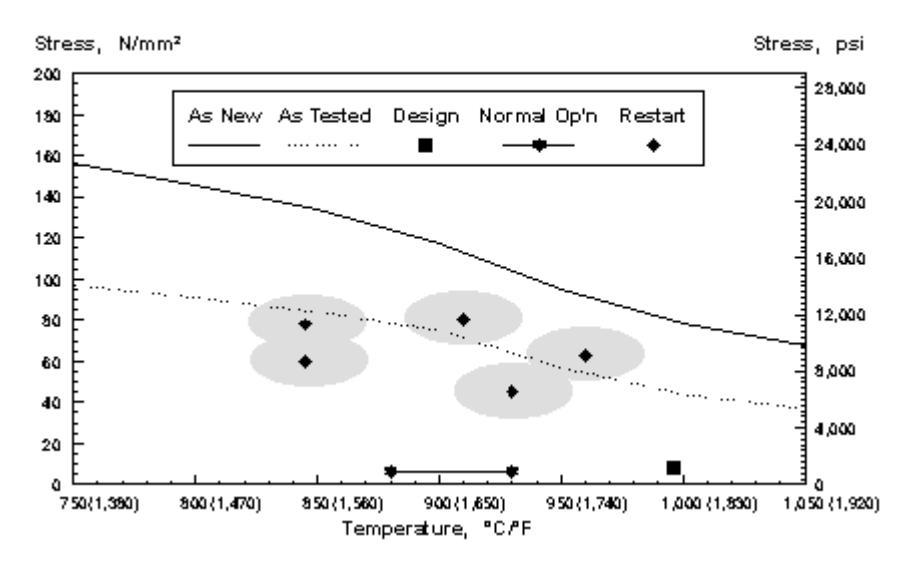
Figure 16 : Transient Stress Compared To Yield Stress

A series of restart cases were modelled in this manner for a range of tube temperatures and steam flows. The results are plotted in Figure 16, along with the design yield stress and the measured yield stress of the as used material. Figure 16 also includes the design point for continuous operation at a stress of 8 N/mm² (1160 psi) and the range of normal operating conditions. From Figure 16, it can be seen that various hot restart scenarios create a series of stresses in the tubes which are 5 to 10 times higher than the design stress, and encompass the current yield strength of the tube metal.
