Investigation of an Unusual Reformer

Tube Failure

Trinidad and Tobago Methanol Company

IMTOF 97

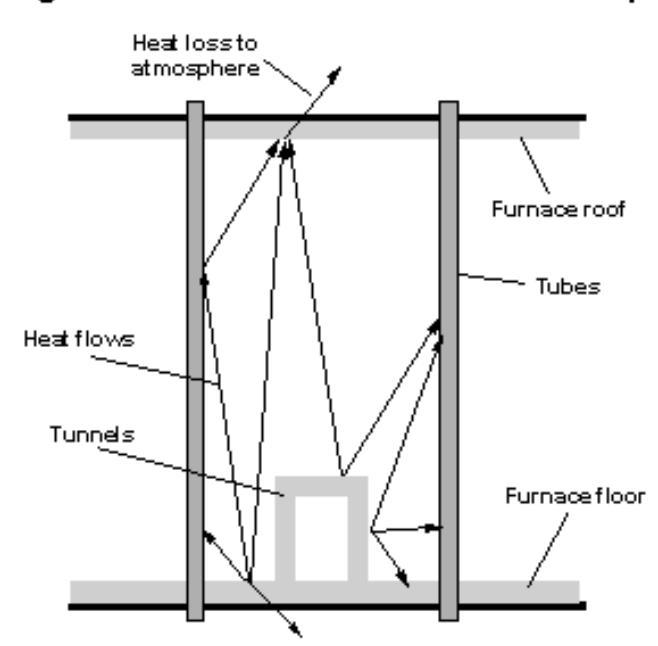
Figure 12 : Heat Flows After Reformer Trip

In order that this effect could be verified a detailed heat transfer model of the furnace was developed for this investigation. The purpose of the model was to calculate how the reformer temperatures varied with time after a plant trip. As a starting point the model used the temperatures measured during the reformer survey. The model then calculated the flow of radiant heat between all surfaces in the reformer such as the tubes, the tunnels and the refractory walls. Figure 12 illustrates some of the heat flows considered within this model.
